## A Dark Day

—Citation for the Navy Distinguished Service Medal awarded posthumously to Comdr. Frank Ragan King, USN, who perished on 12 July 1919 while trying to save his ship—the USS *Richard Bulkeley*, a minesweeping trawler leased from the Royal Navy—and crew.<sup>1</sup>

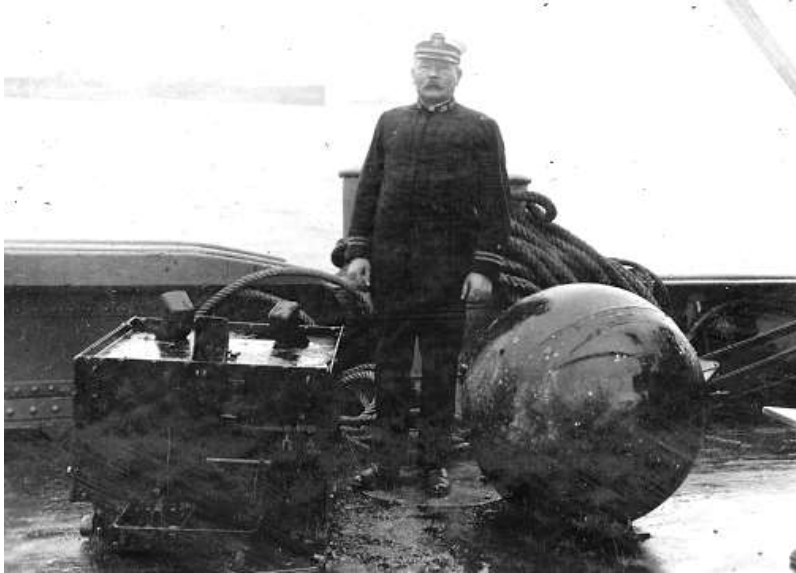
Photo 1-4

An American Mk VI mine, complete with anchor, recovered in the North Sea.  
Naval History and Heritage Command photograph #NH 2507

Of the American and British mines that made up the North Sea Barrage, eighty percent had been laid by the United States Navy. Aside from the huge number, the American Mk VI mine presented almost insurmountable difficulties to planned clearance efforts on account of its novel design and sensitive firing device. The American mines, tens of thousands of large metal spheres packed with TNT, waited passively, suspended in the water column, held in place by tethers to anchors (resembling square metal boxes) on the bottom. Stretching upward from each mine body toward the surface was an antenna, seeking detection of a vessel passing close enough to detonate the explosives.<sup>6</sup>

While methods of sweeping the British mines were understood, there was no known method of sweeping the mines which the United States had laid. With the uppermost end of an antenna at an average of 8 to 10 feet below the surface of the water, it was impossible for a steel-hulled ship to pass nearby without detonating the ordnance. A small piece of iron or steel no larger than a nail was sufficient to trigger the delicate firing mechanism. Consequently, it appeared that only wooden vessels would be safe in such a field, and then only provided that no metal projections, however small, were exposed on the hull of the ships.<sup>8</sup>

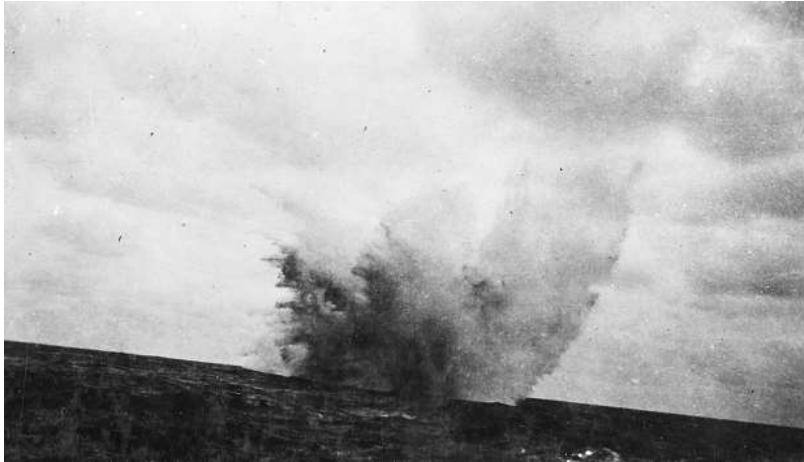
Photo 1-5

The first American mine swept up in the North Sea Barrage, exploding after it touched a sweep wire.

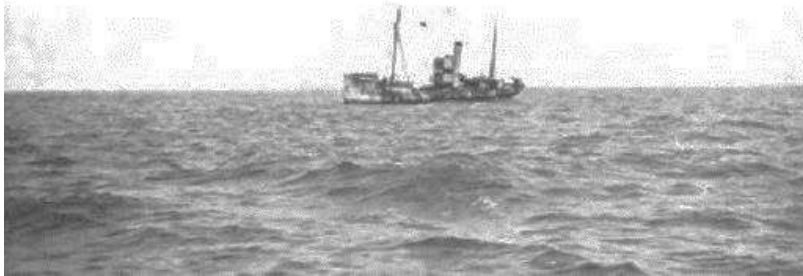
Photo 1-6

Minesweeping trawler USS *Richard Bulkeley* photographed by T. M. Trimble aboard the submarine chaser USS *SC-182*, date unknown.

Rapidly constructed for war service, she, like the *Castle* and *Strath* trawlers, was both economical to build and to operate. Powered by a single coal-fed boiler—providing steam to a 3-cylinder triple expansion engine, driving a single shaft and propeller—she could make a modest 11 knots. Her armament was equally austere. A single 12-pound gun

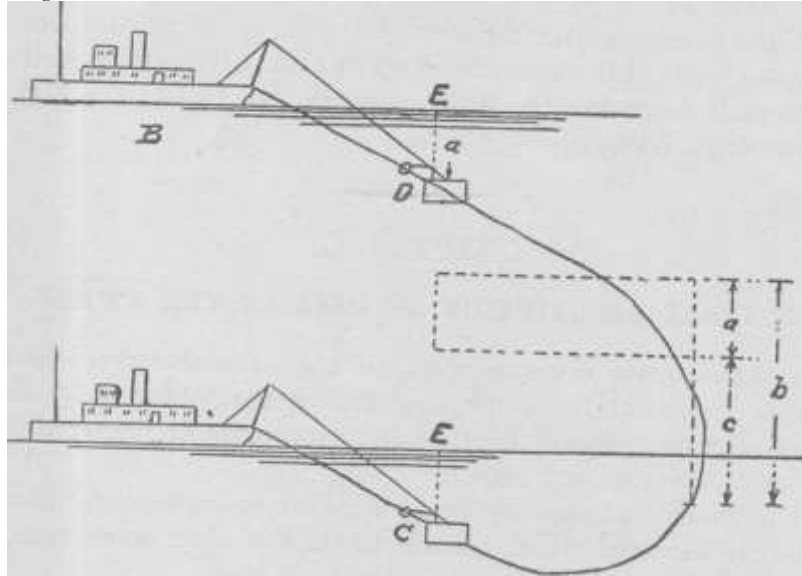
Diagram 1-2

Diagram of two minesweepers steaming abreast of one another, at a distance apart about equal in yards to the number of fathoms of sweep wire out. The bight formed in the shared sweep wire, upon encountering the mooring cable of a mine in its path, either dragged the mine along with its anchor or, by seesawing, cut the mine's cable, letting the mine float to the surface, where it could be destroyed with gunfire. It was also possible that the sweep wire itself might explode the mine.

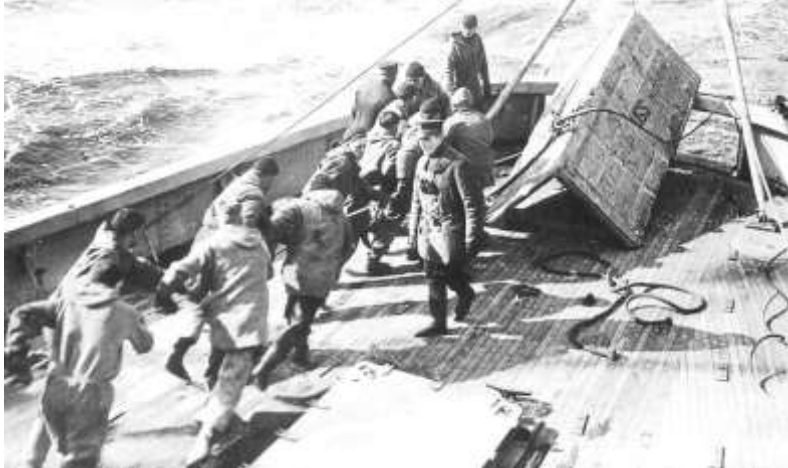
Photo 1-7

Minesweep detail aboard the USS *Tanager* handling a "kite," circa 1918-1919.  
Naval History and Heritage Command photograph #NH 107321

Shortly before sunset on 12 July, *Richard Bulkeley* was sunk by the explosion of a mine fouled in the "kite" of her sweep gear. The Mine Force was using Type 7 plunger kites obtained from the British, a device which resembled a section of the wing of an airplane, except that it rode upside down in order to fly downward instead of upward. Although innovative at the time, the sweep gear was by the standards of WWII, rudimentary. There were no buoys to keep sweeps from striking the bottom, nor cutters affixed to sweep wires to sever the moorings of mines. Pairs of *Lapwings* operated together to clear the mines. Steaming abreast, with one end of a heavy wire made fast to each ship. Formed into a U-shaped catenary pulled down by a kite astern of each ship, the minesweepers employed the sweep wire to part (saw through) the wire cable moorings of tethered mines. Since this was done by friction,
